Mitigation Site Visit Bartlett, NH

WO's 18135 & 18298

May 4, 2018

Re: Saco River site visit summary from August 15, 2018

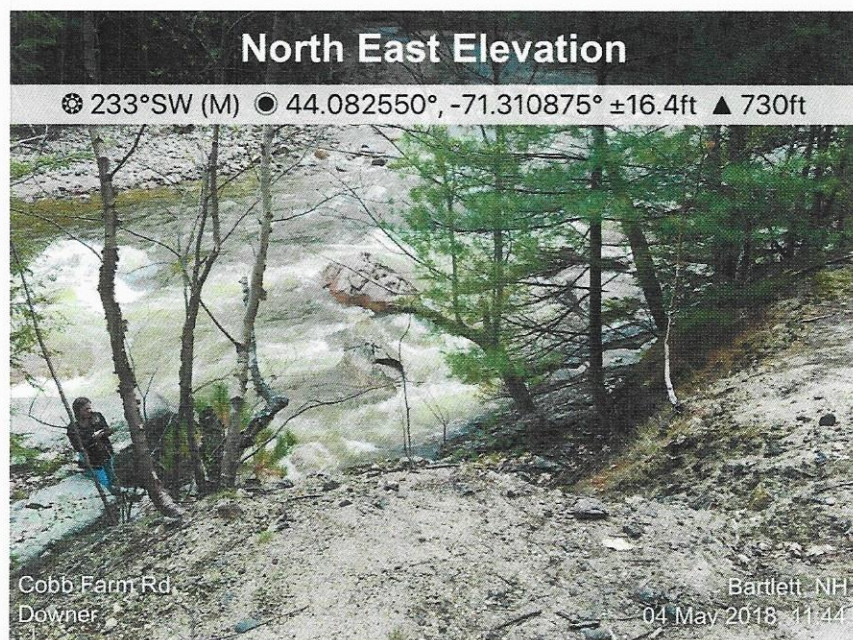
Standing on the road edge, one gets a view of what appears to be slope failure.

The adjacent photo shows the apparent gully and large boulder.

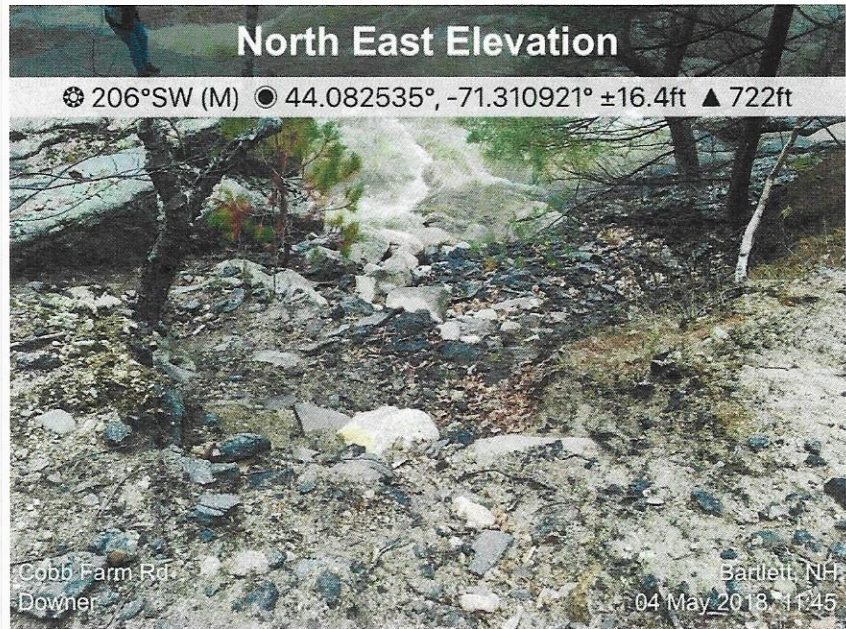
A closer view shows that the apparent gulley is covered with broken asphalt.

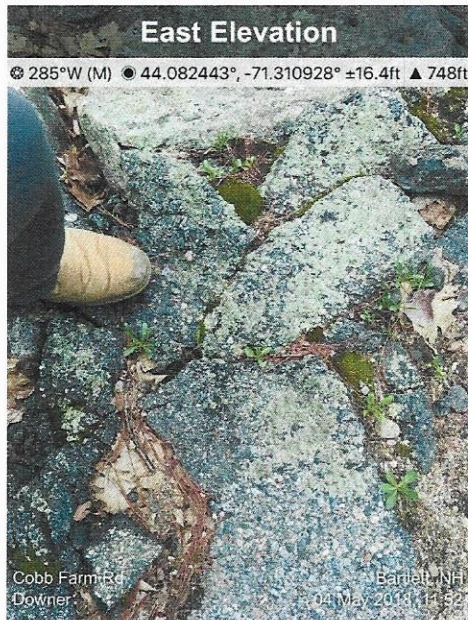
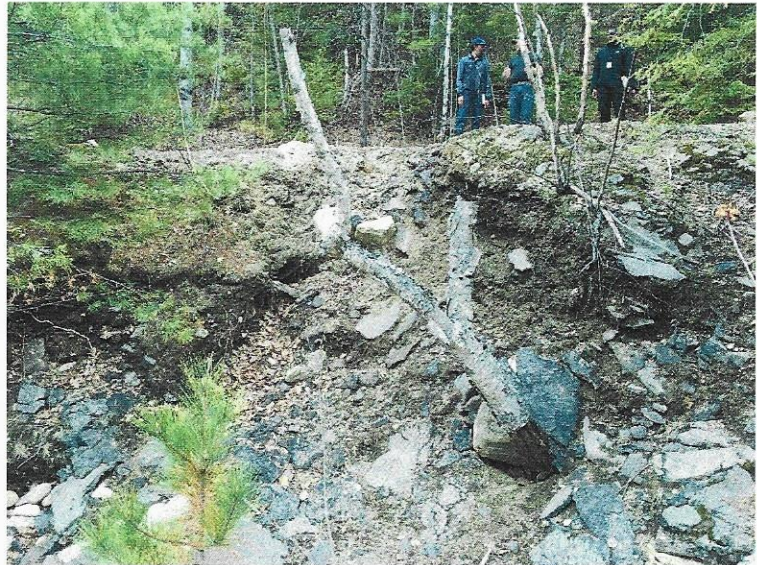
At some earlier time the Applicant tried to stabilize the gully by dumping asphalt chunks over the bank.

The asphalt chunks were place a long time ago, as they are covered with lichens.

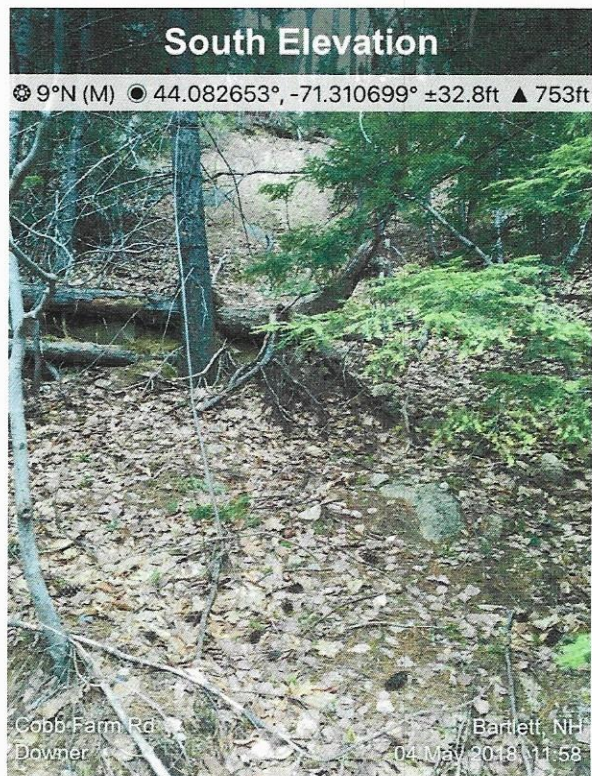
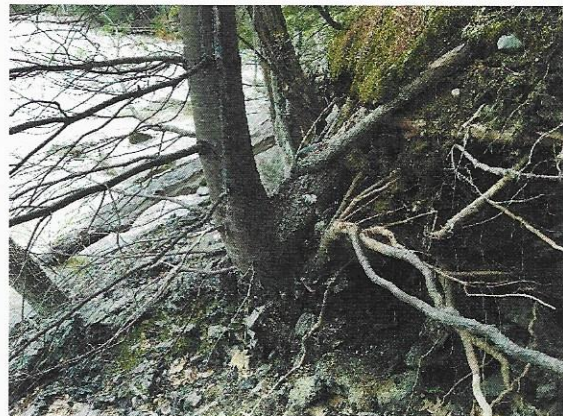
The river bank in this area has been unstable for many years. The bent tree trunks are witnesses to the slow downward movement of the slope.

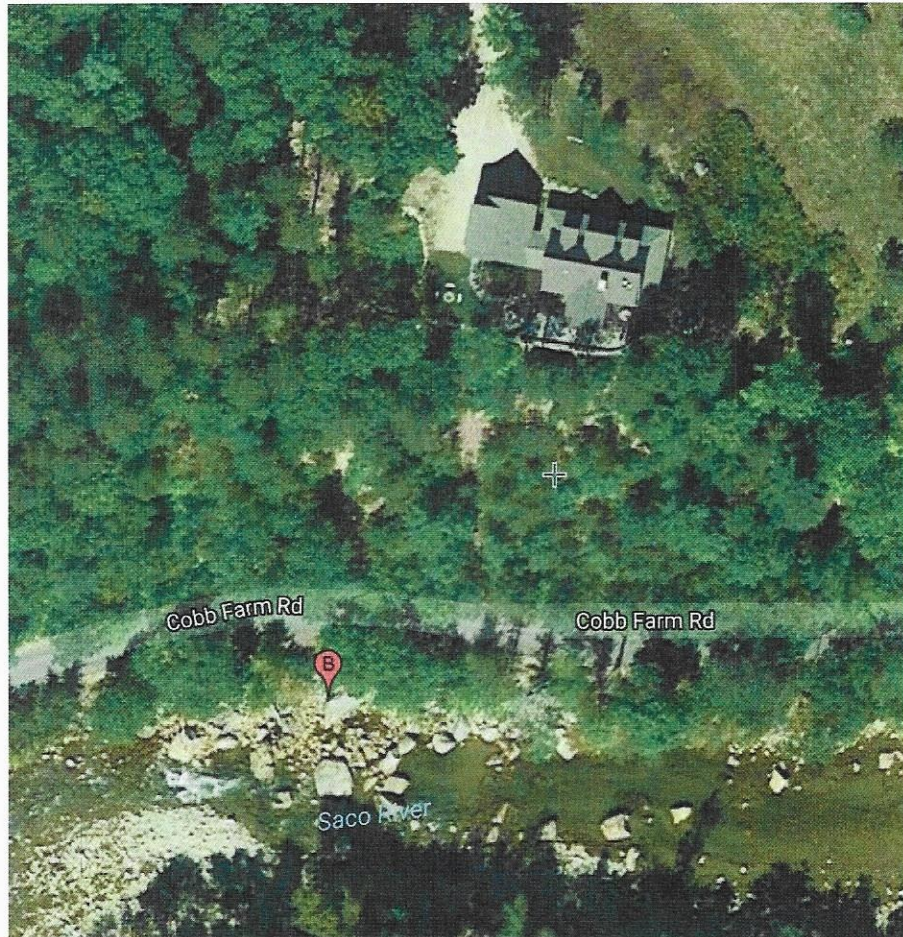
Further investigation revealed a gully immediately uphill of the river-bank gully (to the south). There is a 10-foot un-vegetated escarpment at the top of the slope and evidence that water frequently flows down the slope and across the road toward the river bank gully.

Aerial photos from ACME Mapper suggest that the source of the excess water running down the slope is the grounds surrounding a large house at the top of the bluff.

The un-vegetated scarp is clearly visible mid-way down the slope.

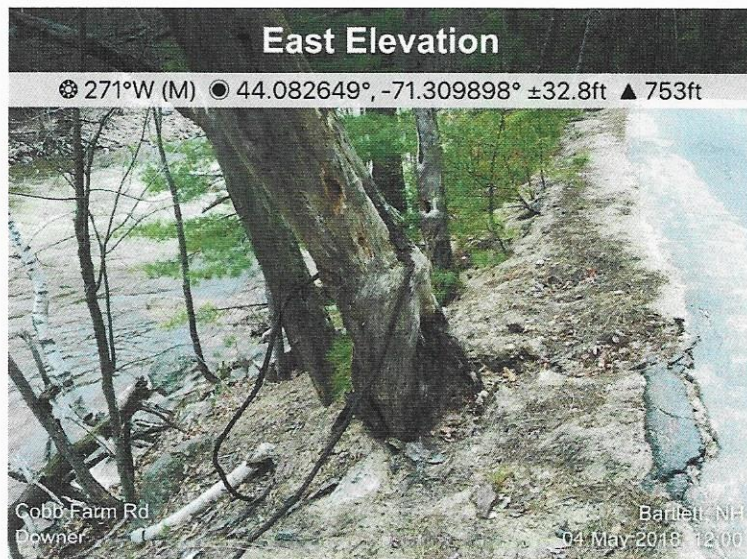
Over the years, the Town has slowly widened Cobb Farm Road; now a 20-foot wide pavement. The roadway was once protected by guard posts with cables. The cables can be seen embedded in trees and partially buried along the edge of the road shoulder.

Over the 700 feet of roadside slope there is ample evidence in the form of leaning trees and bent tree trunks, that the slope is unstable.

The toe of the slope at the river's edge is exposed rock, but there was little evidence of bank erosion at the toe.

While there may be some water coming from the road the majority of the damage to the bank came from the October storm undermining the bank. This is caused in part by the gravel bank upstream and opposite the site, forcing the river up against the bank. The Town road needs to be protected as it is a dead end and the only access. Surely the road might be a bit wider now than 100 years ago but there has been no widening in recent memory. There is not any room to widen.

#### **Suggested Mitigation**

None.

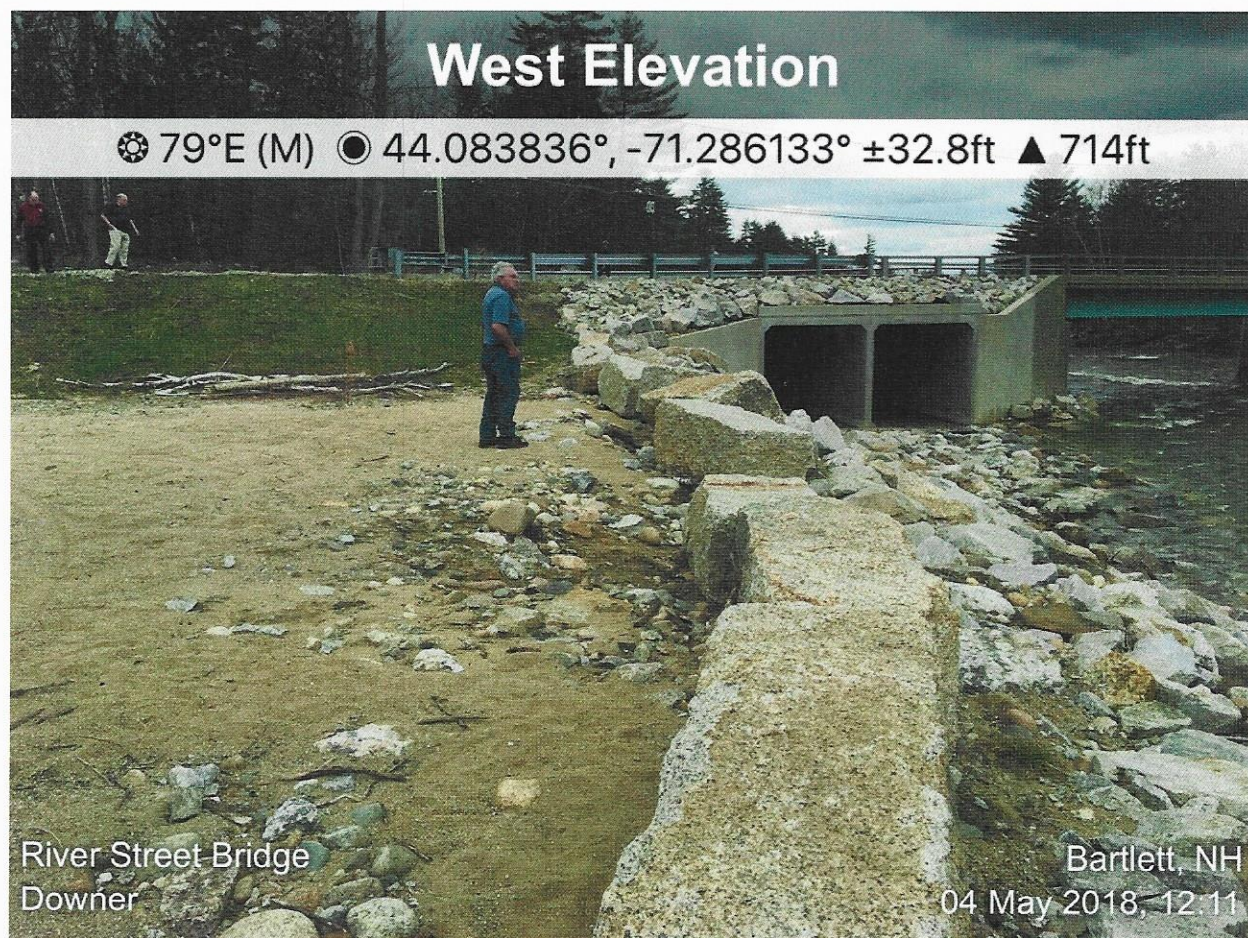
During the declared event, flood waters rose to near the level of the road surface, but did not flow over the road. At its highest flood level an eddy formed above the box culvert. This eddy swept the riprap away and caused a section of the bridge approach asphalt pavement to collapse.

Repairs were 100% complete on this date, May 4, 2018.

As mitigation, the Road Agent suggested that he would like to extend the concrete wing wall by ten feet northwest. And, to riprap the, now grassed, road embankment for a distance of about an additional 40 feet. The intent being to armor the bridge approach should the flood waters again raise above the parking lot in the foreground.

The final plans for mitigation will be dependent of the Cost to Repair to Pre-disaster Condition.

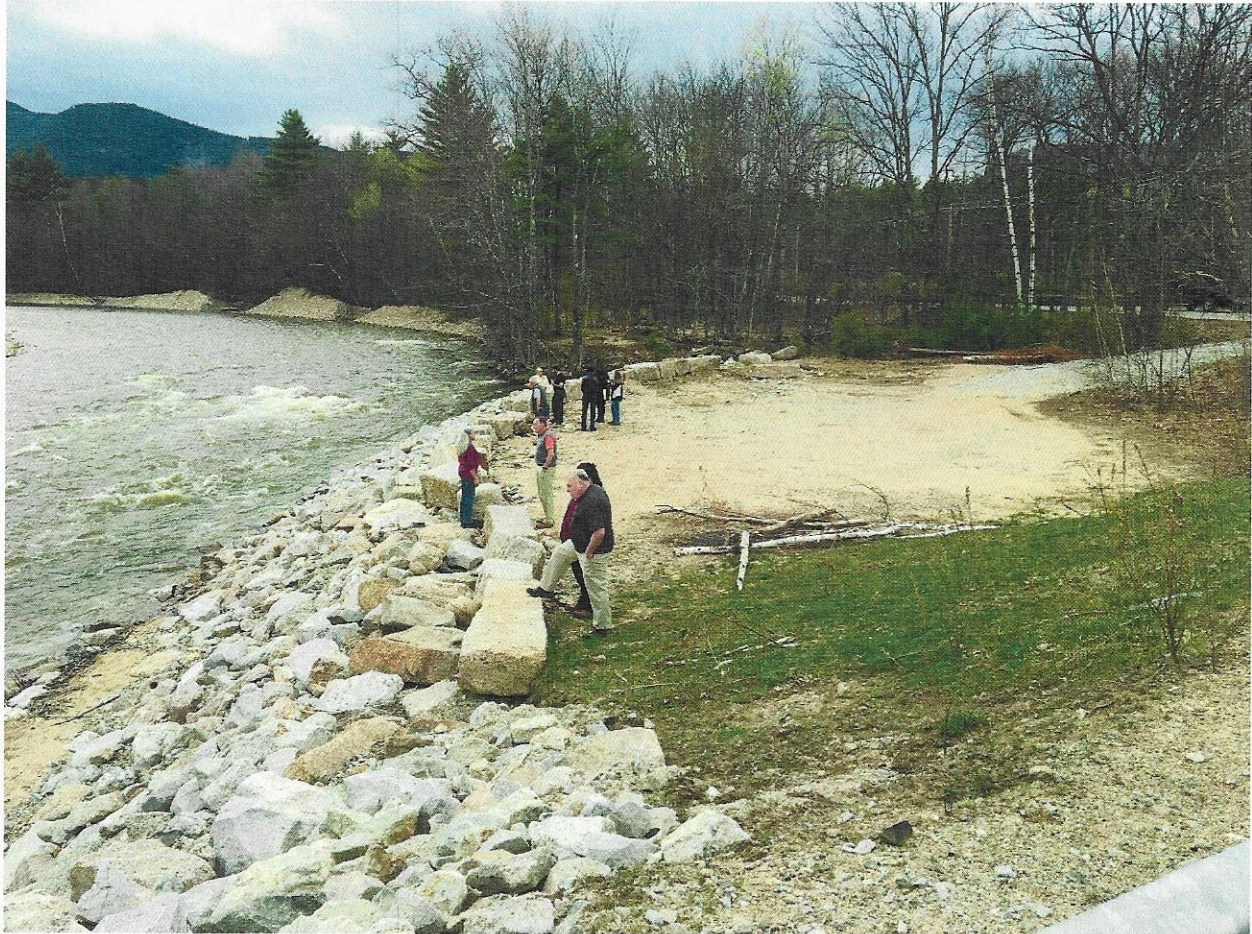
The photo below shows one of several breached berms. This one is just upstream of the River Street Bridge. The berms were constructed on both sides of the river sometime in the 1950's. The berms are all on private lands. At this time, it is not clear who authorized their construction, who paid for the work or who was responsible for their maintenance.

While the berms may be on private land the Federal Government through the Army Corp of Engineers and FEMA have on at least three occasions been involved in paying for work on these berms. Clearly there should be no confusion as to who paid for the work; Federal Government, State of NH and Town of Bartlett or who authorized the work.

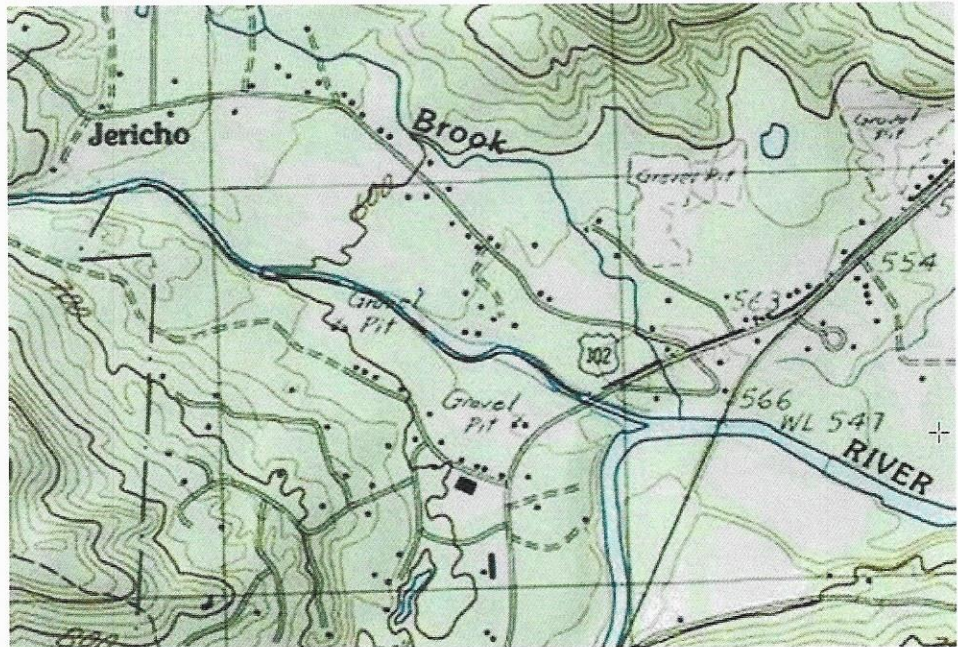
During the declared event, Mountain Brook jumped its banks and ran down the north side of Jericho Road before crossing Route 302 and then flowing down Sleepy Hollow Road toward the Soco River.

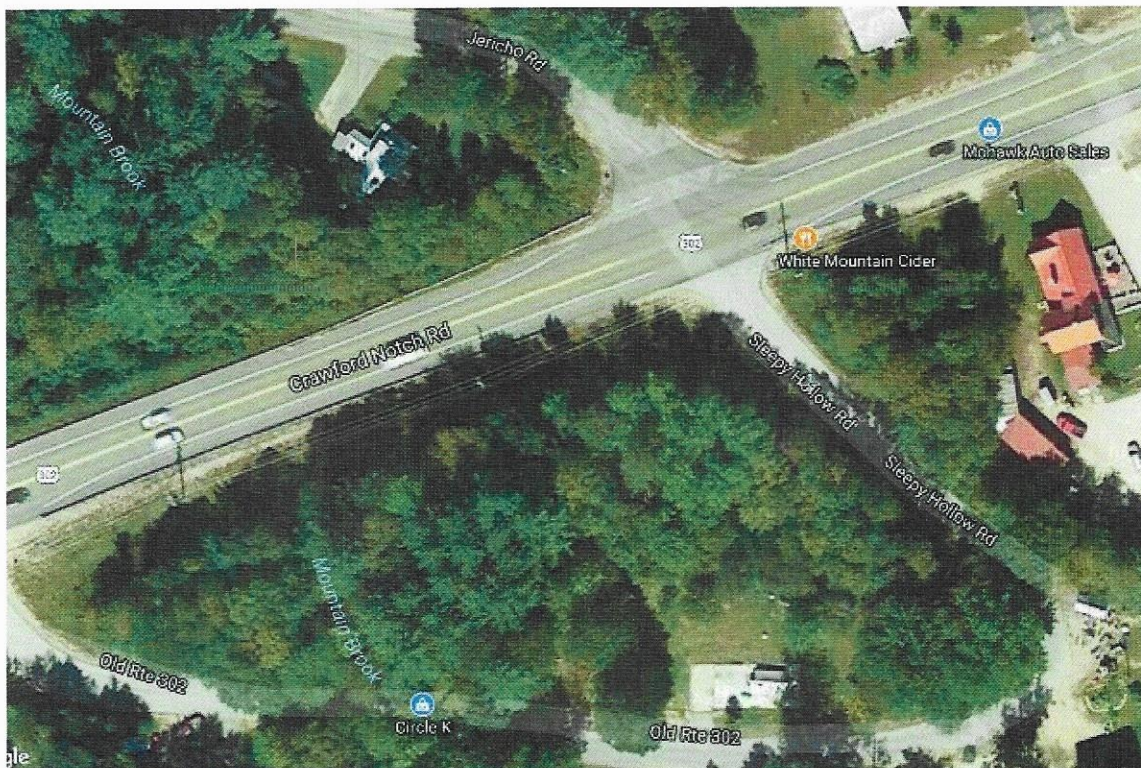
Both properties on either side of Jericho Road, at the Route 302 intersection, received flood damage. The east property sits up high, while the west property sits in a low spot. The house was flooded. Only gravel was lost on Sleepy Hollow Road.

While Mt. Brook may have (not sure) jumped its banks the major impact of the damage was done by the Rocky Branch River. To the stated position that only gravel was lost on Sleepy Hollow Road, the Town just paid for the paving of that road as a result of the storm and in fact are submitting the bill to FEMA as it has been approved as a project.

**Mitigation**  
None.

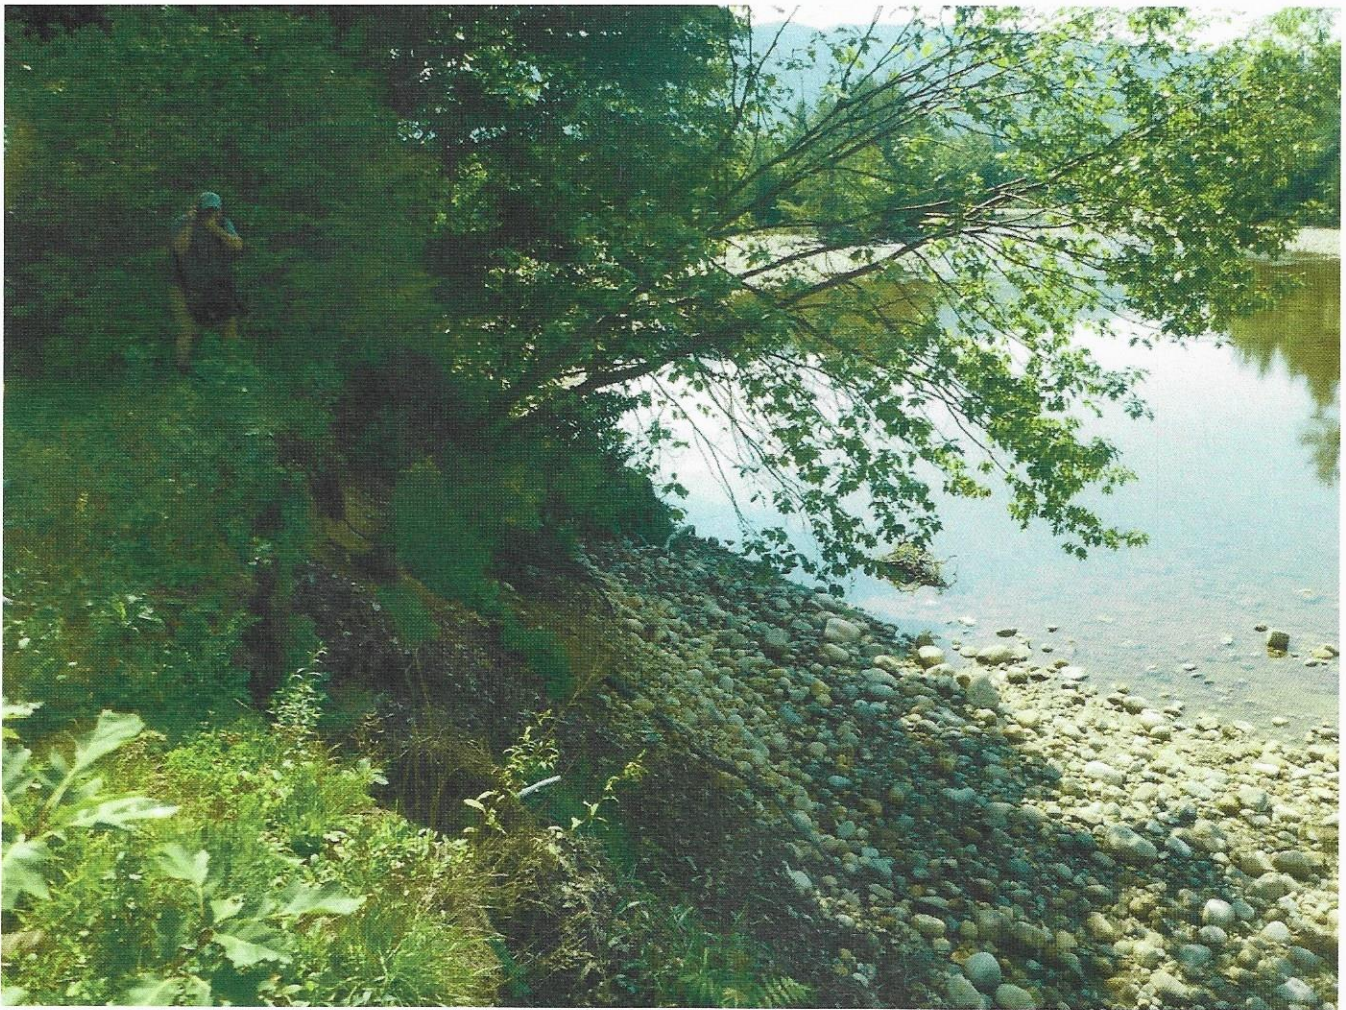
**Figure 4.** View taken within the eroded bank area near the center of the violet circle in Figure 3. Note the break in tree canopy along the bank as compared to that shown in Figure 3.

Although aerial imagery does not exist since 2016, the 2015 aerial imagery was used in order to estimate, within ArcGIS, the lateral extent of bank erosion based on the current bankline position relative to the shed at the east end of the eroded area, as observed on August 15, 2018. The result is approximately 25 feet of lateral (landward) erosion.

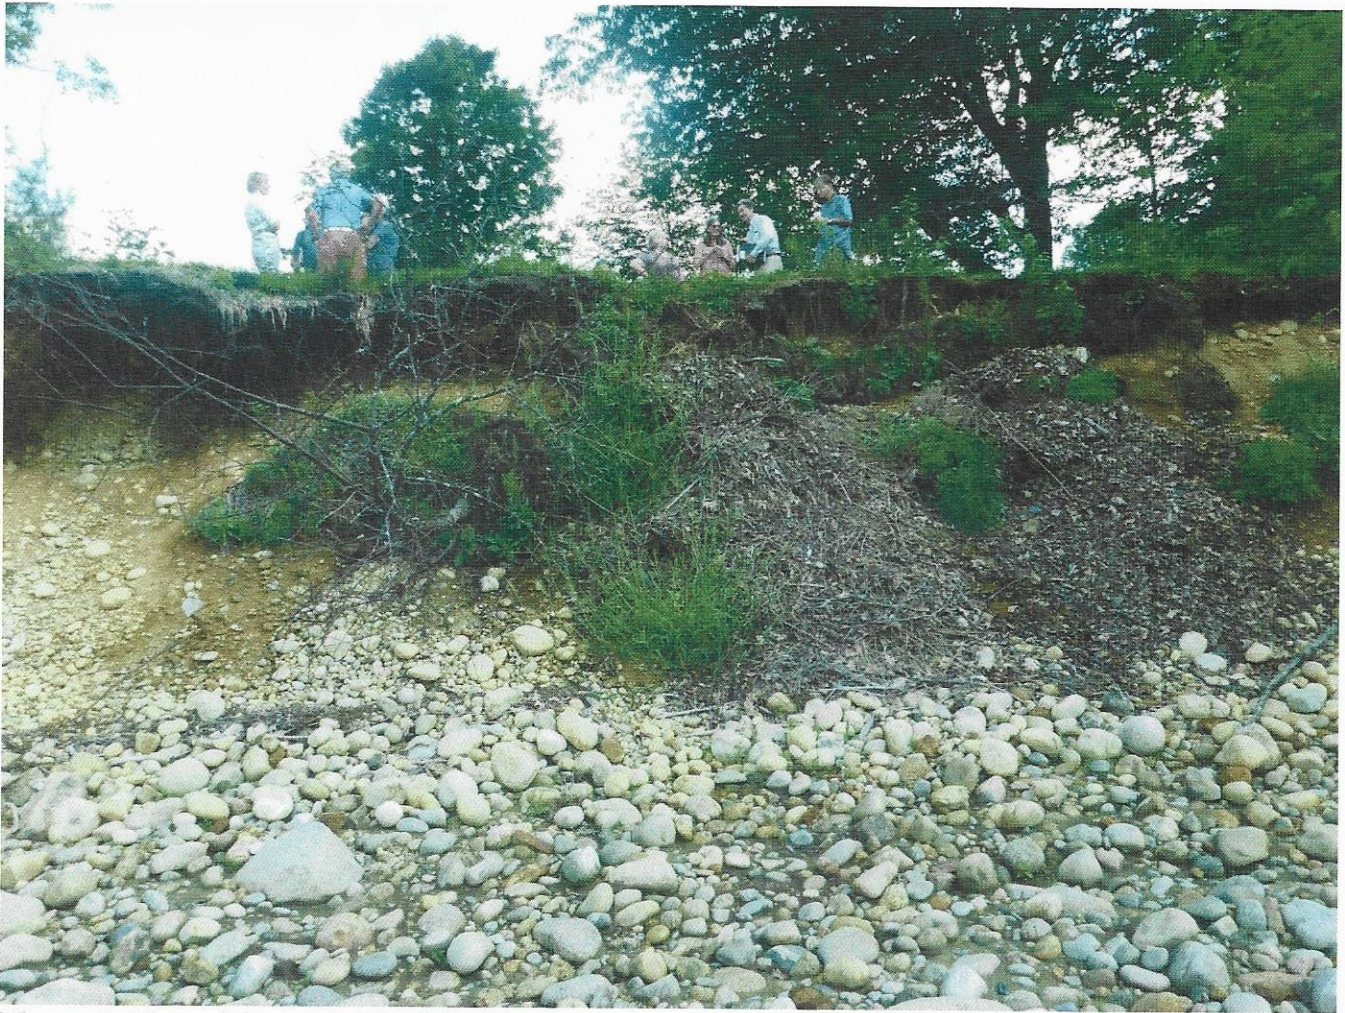
**Figure 5.** View of the eroded bank looking up at the top of the current bank. This photo was taken from within the area of the violet circle in Figure 3. Note the lack of tree canopy, as compared to the continuous canopy shown in Figure 3.

Given the existing situation at the Yates Farm site, the loose bank material is completely exposed to the flows of the Saco River. There are cobbles that have been plastered at the base of the bank which will act to protect the base (Figure 5), however, higher flows will continue to erode this bank and cause it to fail. The rate of further bank erosion cannot be precisely predicted. The downstream extent of the eroded area is located adjacent to the corner of the shed at the east end of the site. Given the erosion occurring just upstream, the progression of further bank erosion in the downstream direction is very plausible.

If bank stabilization is an option to be considered in the future at this location, an engineer will need to be retained to calculate a design that will ensure large angular stone is of sufficient size to resist the shear stresses directed into the bank at higher flows. The base of the bank would also likely need to be reconfigured in order to allow the stone protection to be keyed into the bed to maximize future integrity. A design engineer that examines this situation should also be asked to contemplate whether a bioengineered solution could work here. Yet, the engineer would also need to calculate whether a bioengineered solution could survive the shear stresses directed into the bank at this location, and if the bank angle has too great a vertical component to allow such a solution.

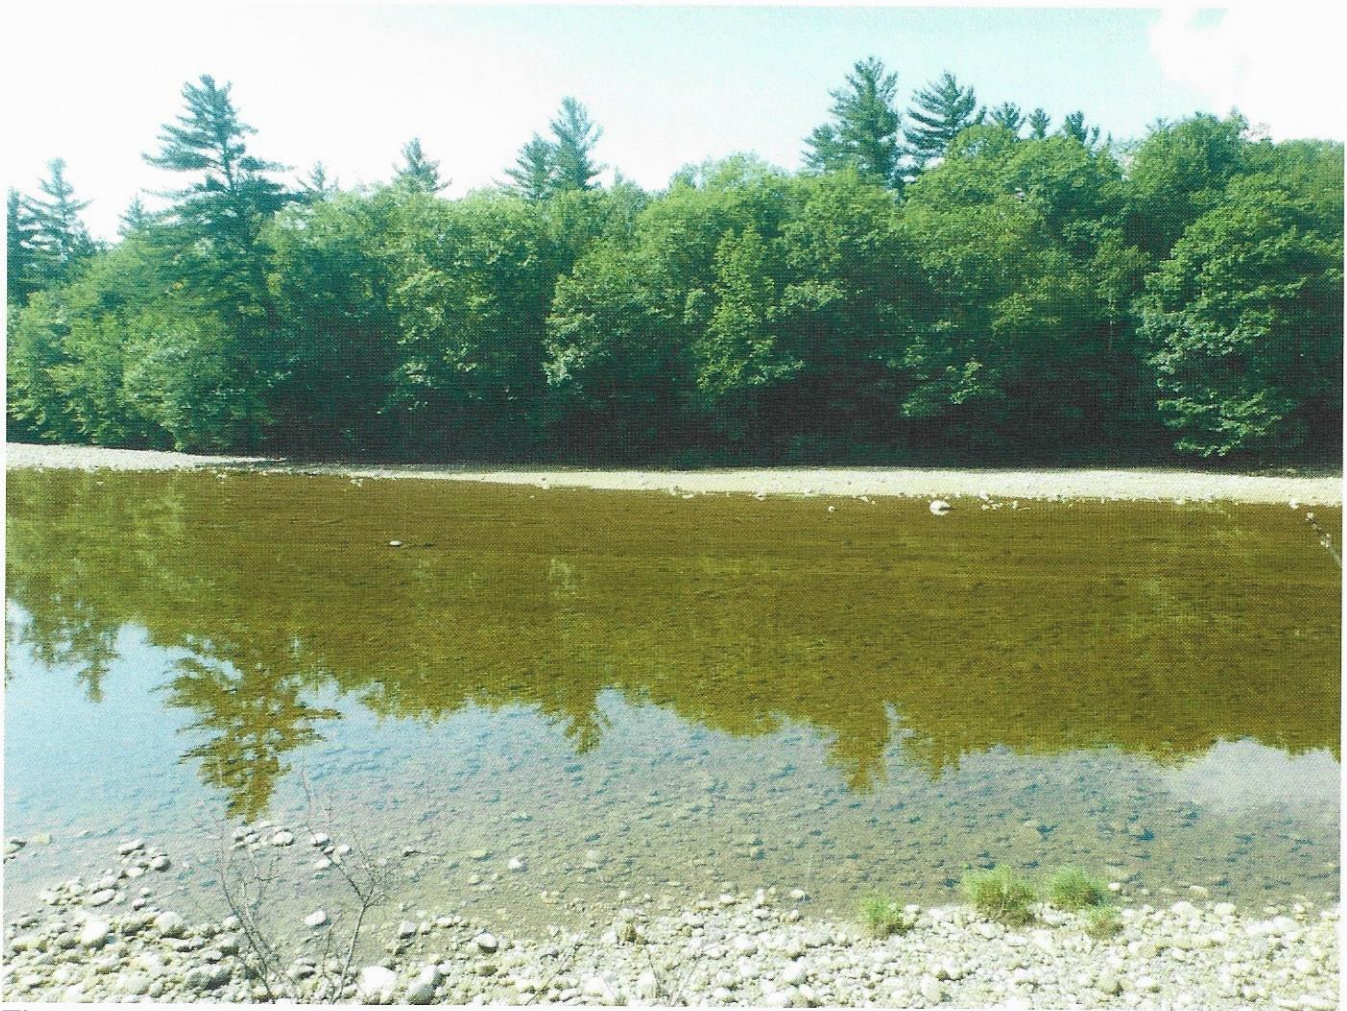
It is a known fact that the River Street bridge and approaches are serving to constrict the Saco River and attendant sediment transport processes at that point, including sediment deposition upstream. This has been covered in previous summaries. In rivers, when sediment becomes trapped upstream of a constriction, the river downstream will be “hungry” for sediment – which means that a river will seek to erode sediment from elsewhere, such as the bed or banks, in order to re-attain a sediment load that is in balance with its sediment transport carrying capacity. Thus, erosion is typically seen on rivers and streams downstream of constrictions. As seen in Figure 6, the Saco River bed in front of the Yates Farm site is relatively uniform across the channel. This is likely exacerbating bank erosion by forcing flows laterally into the outside of the meander bend.

**Figure 6.** View of Saco River bed in front of Yates Farm site. Note the low-flow shallow and uniform depth across the channel.
