Mitigation Site Visit Bartlett, NH

WO's 18135 & 18298

May 4, 2018

Re: Saco River site visit summary from August 15, 2018

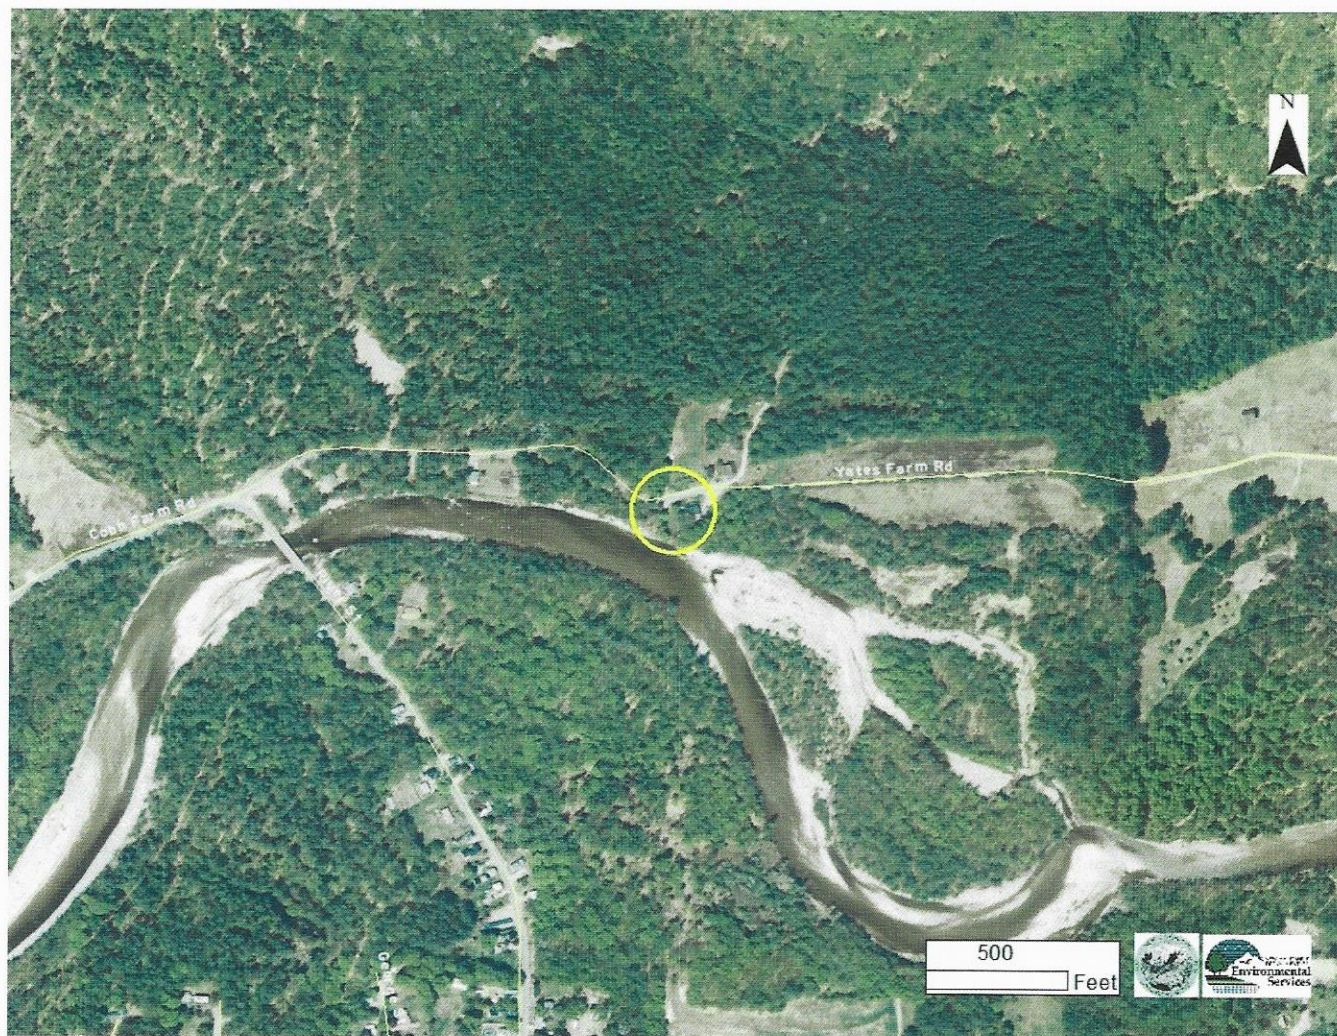
Figure 1 shows an overview of the Saco River from the River Street bridge to the Yates Farm site on aerial imagery from 2015. Note the existence of bank erosion on river left upstream of the yellow circle (Yates Farm site). However, a closeup of the Yates Farm site on the same aerial imagery (Figure 2) shows that no, or limited, bank erosion was occurring in the 2015 aerial imagery. Lower-resolution 2016 aerial imagery, taken at leaf-out (Figure 3) shows considerable tree canopy during the summer. However, there are signs, based on an indentation in the channel morphology (violet circle; Figure 3) that flow had begun to cut into the bank in this image.

**Figure 1.** Overview of Saco River in vicinity of River Street bridge crossing. Yellow circle demarcates the Yates Farm site.

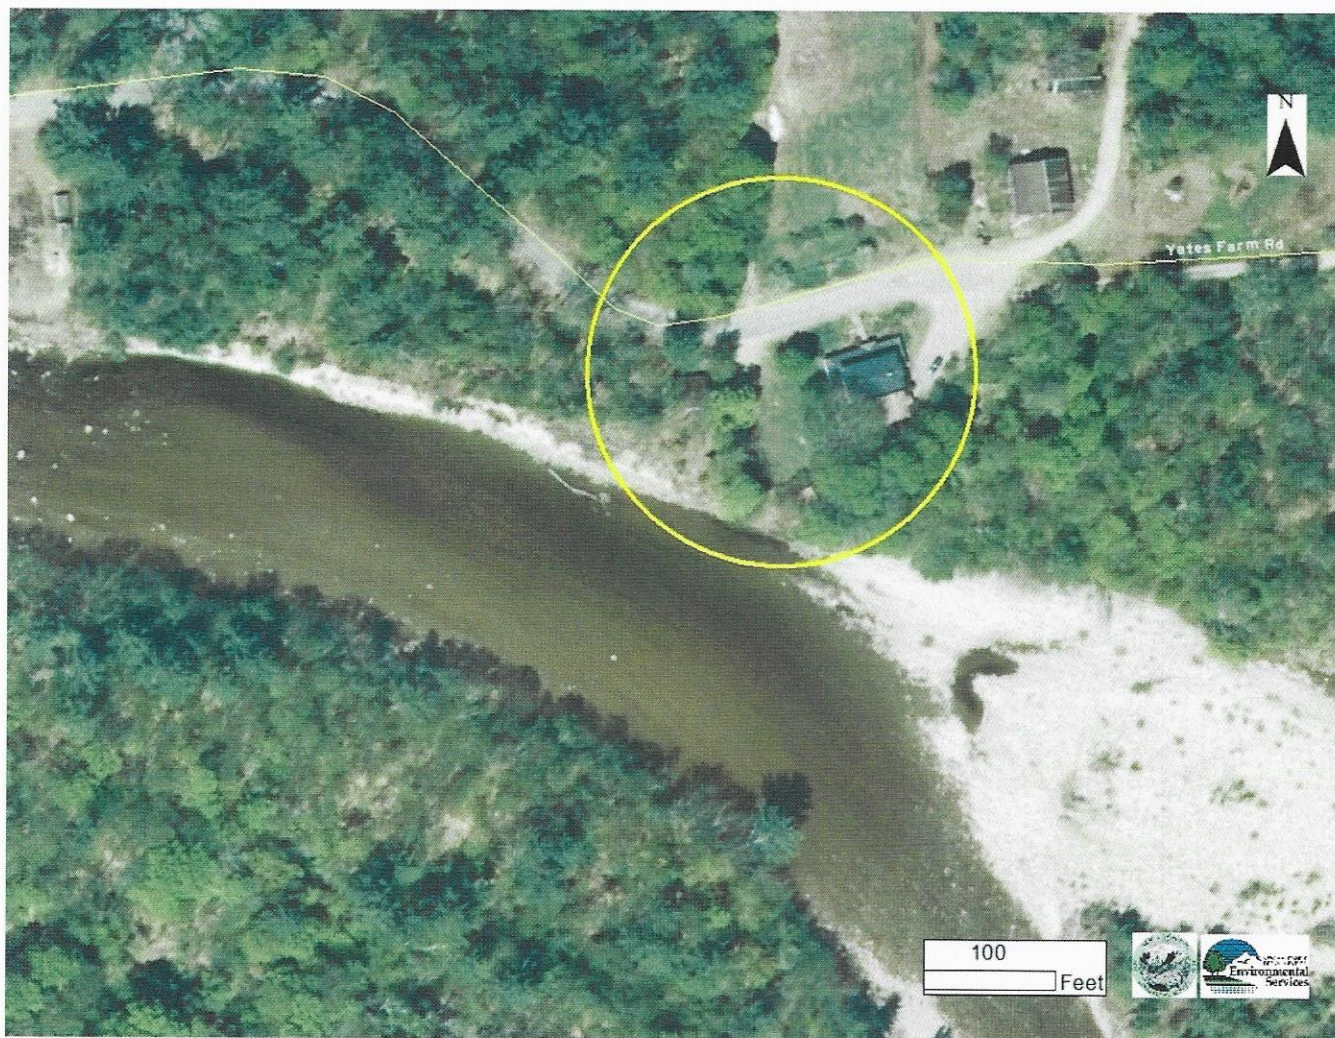
**Figure 2.** Close-up view of the Yates Farm site in 2015 aerial imagery. Note tree canopy along the bank in front of the lawn of the property. Also note that the integrity of the bank at this location appears intact. Note the bank erosion directly upstream, however.

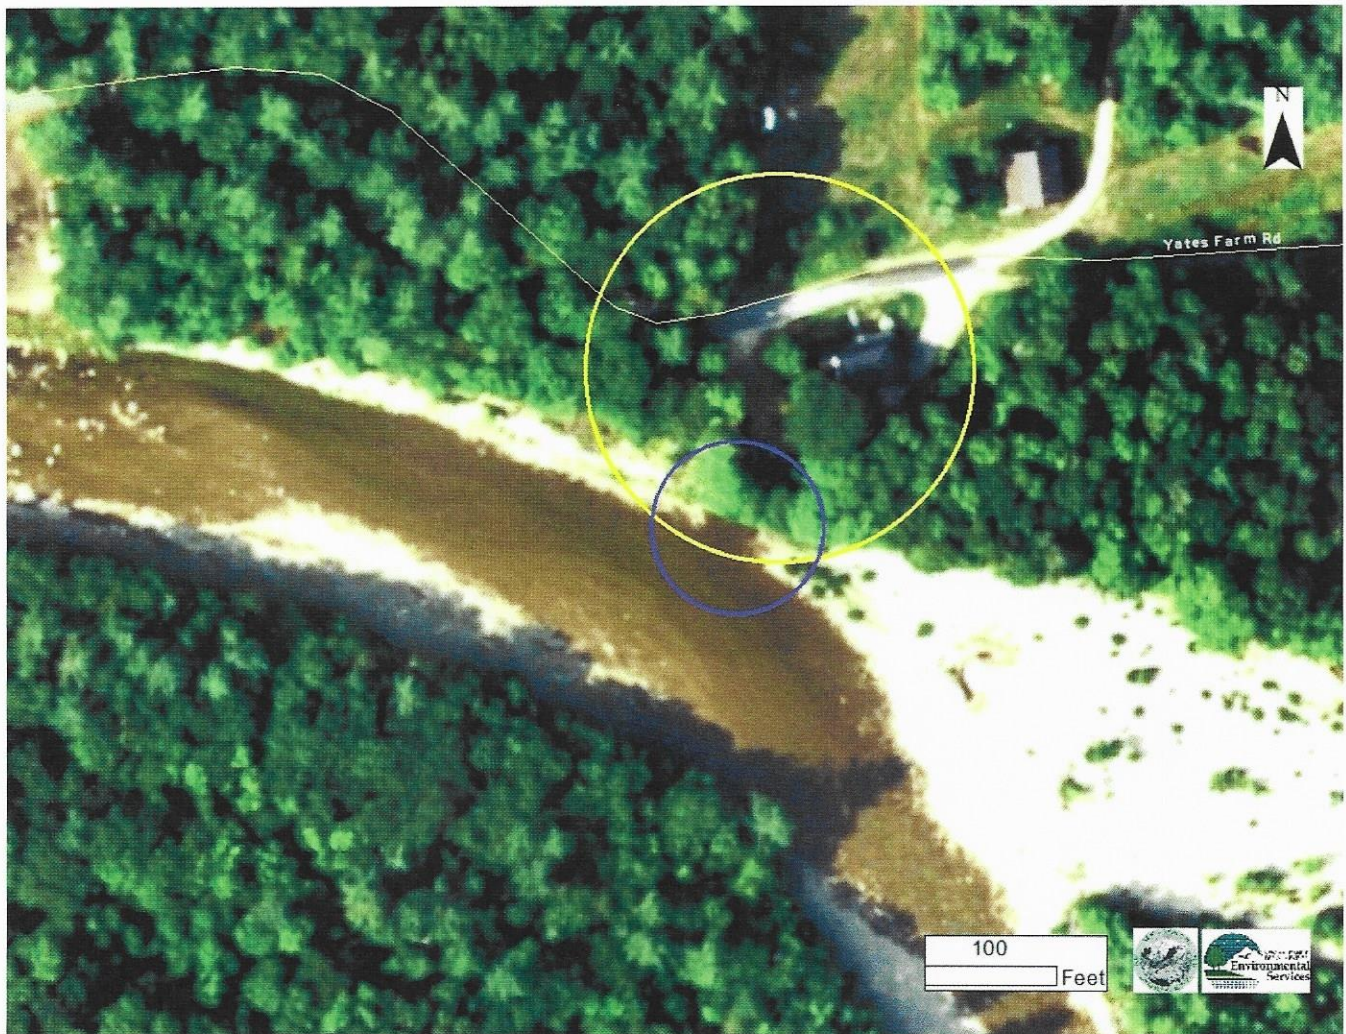
**Figure 3.** Lower-resolution aerial imagery from Summer 2016. Note the tree canopy in front of the lawn of this property. Note the indentation in channel morphology in front of the bank (violet circle).

Although aerial imagery does not exist since 2016, the 2015 aerial imagery was used in order to estimate, within ArcGIS, the lateral extent of bank erosion based on the current bankline position relative to the shed at the east end of the eroded area, as observed on August 15, 2018. The result is approximately 25 feet of lateral (landward) erosion.
